Professor Carsten Rode,  
Technical University of Denmark, DTU  
Department of Civil Engineering

# **Some Recent Challenges and Peculiarities in Moisture Practices and Assessment of Buildings**

# Experiences with MgO Boards

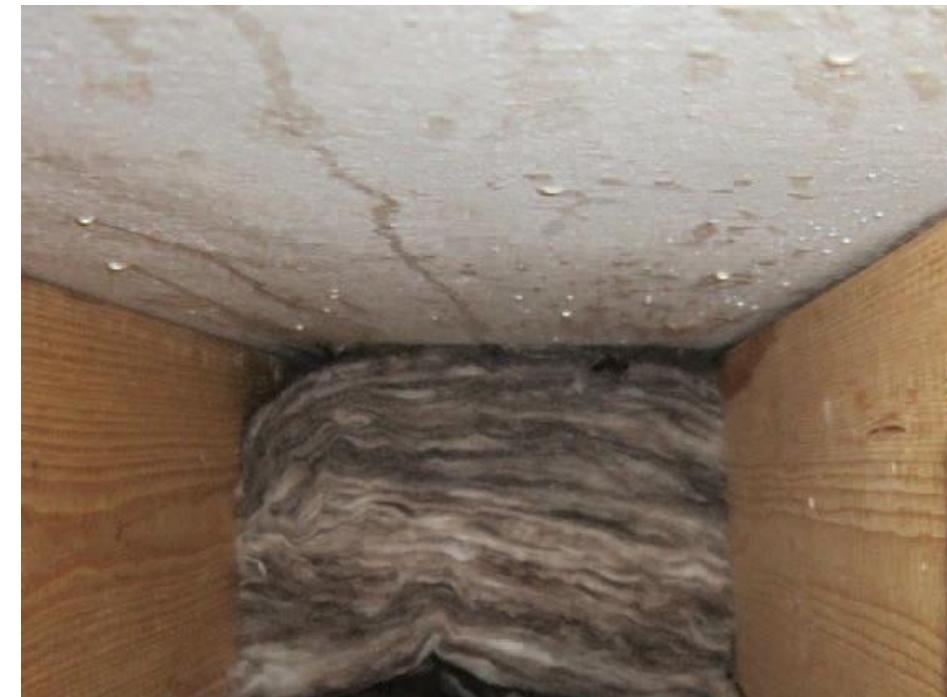
Photo: Tommy Bunch-Nielsen, BUNCH Building Physics, ApS

## Problems Due to Content of Salt, $MgCl_2$

- Moisture absorption from the surrounding air
- At high humidity the boards start "crying" salty tears
- Corrosion of metal parts from  $MgCl_2$
- Mould growth due to content of wood fibres/saw dust
- Decomposition

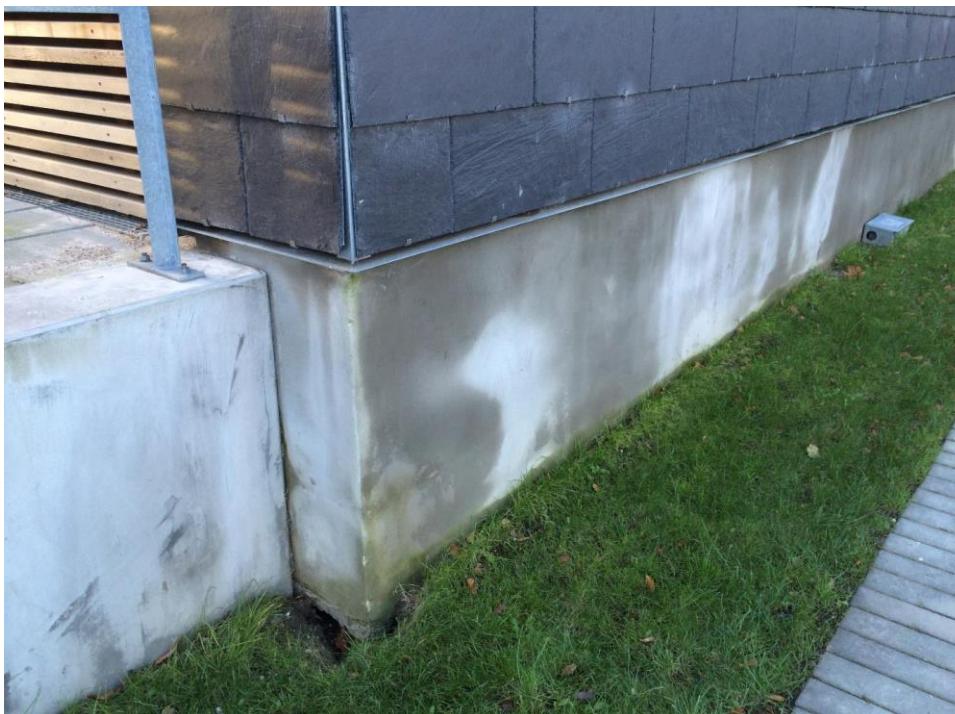
Photo: Tommy Bunch-Nielsen, BUNCH Building Physics, ApS

## Salt Water Absorbed in Concrete Foundation

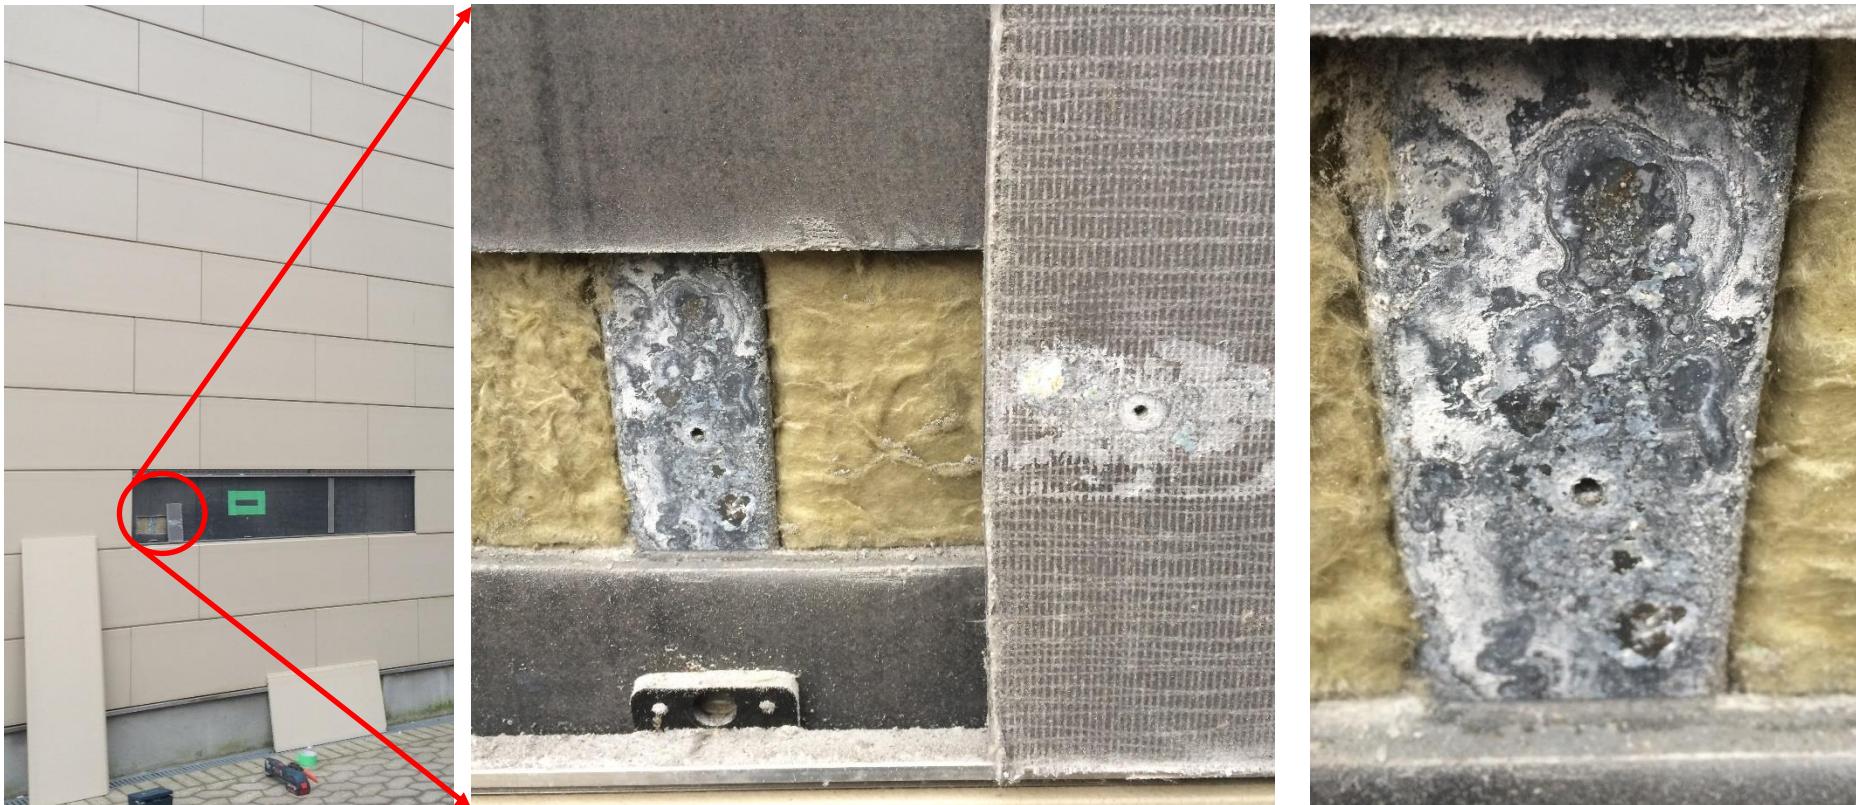
Photos: Tommy Bunch-Nielsen, BUNCH Building Physics, ApS

## Corrosion of Galvanized Steel Behind MgO boards

- Salt from MgO-boards is highly corrosive on metal fasteners and profiles.
- Zink flashings of 0.8 mm corrode in 1-2 years.
- Electro galvanized steel profiles, nails and screws will corrode to the steel in 1-2 years.
- Aluminum alloys have different resistance against corrosion and the best alloys have been seen undamaged for 2-3 years.
- Stainless steel type A2 and A4 can be used without problems.
- When MgO boards have been sitting on a wooden structure,  $MgCl_2$  salt will have been absorbed by the wood, which is then corrosive to metallic fasteners other than stainless steel

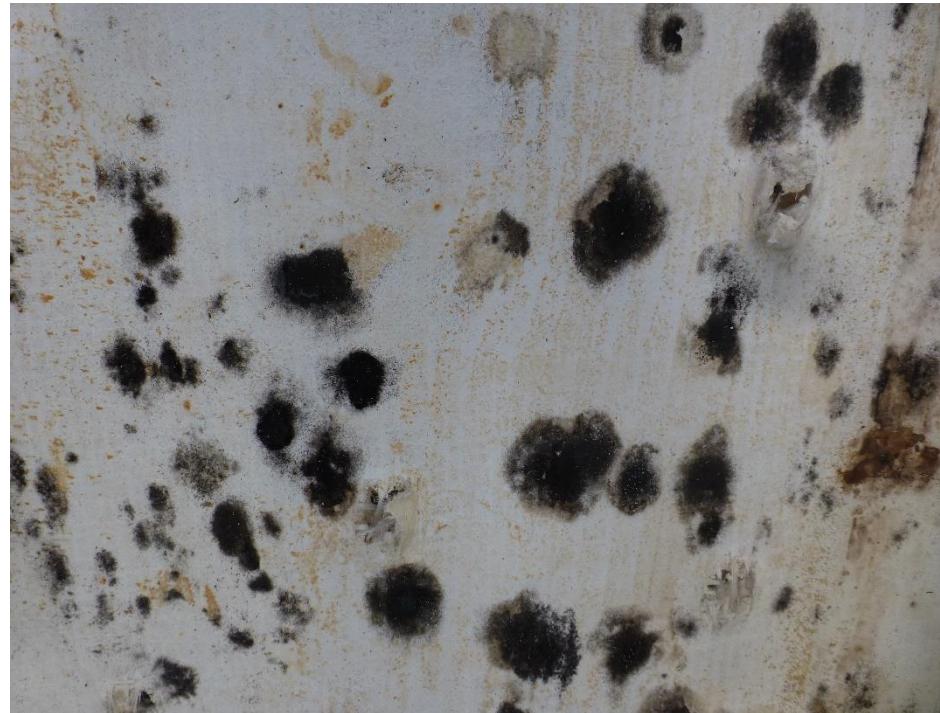
Photo: Tommy Bunch-Nielsen, BUNCH Building Physics, ApS

## Mould Growth on the Surface of MgO Board

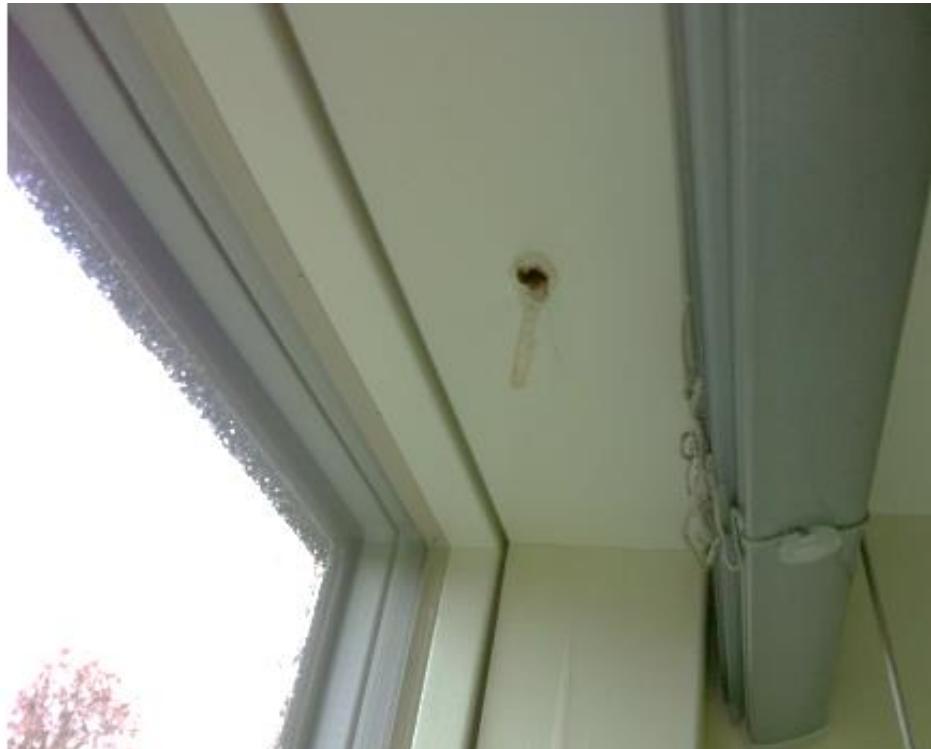
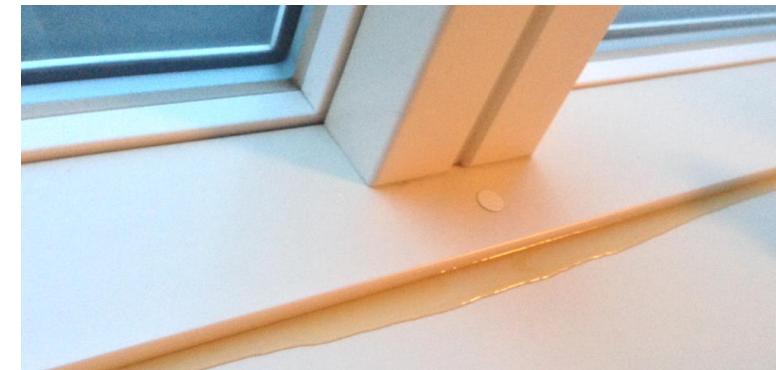
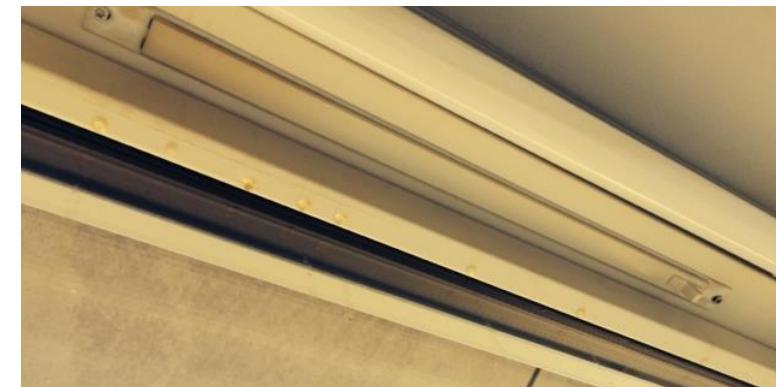
Photos: Tommy Bunch-Nielsen, BUNCH Building Physics, ApS

# Water Penetration in Windows from the MgO Boards

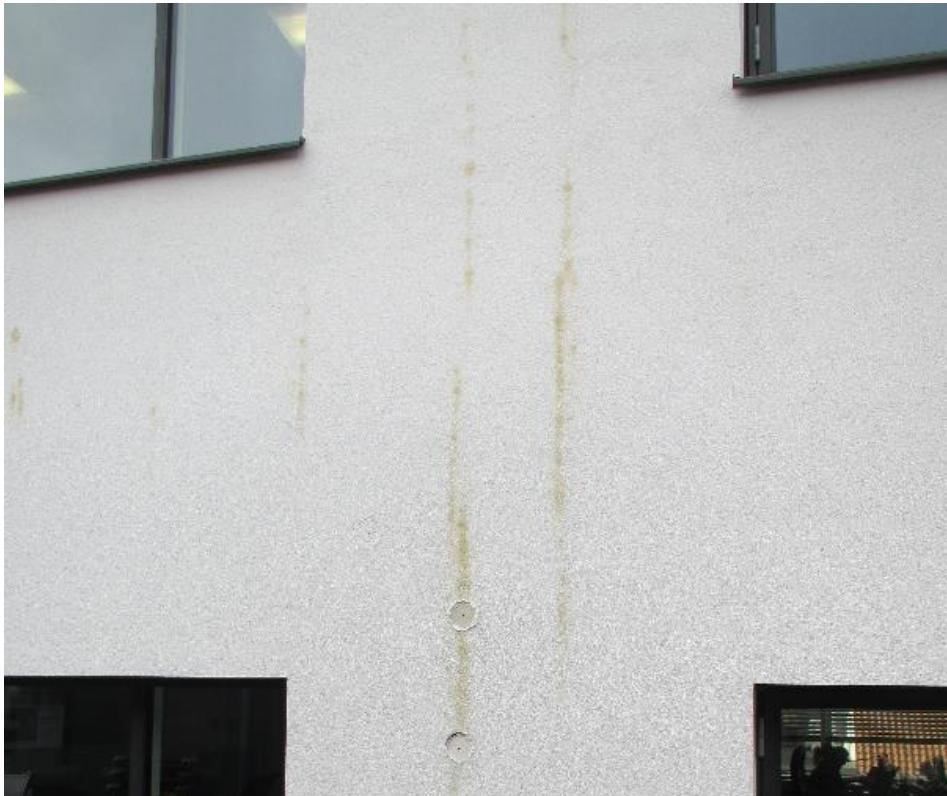
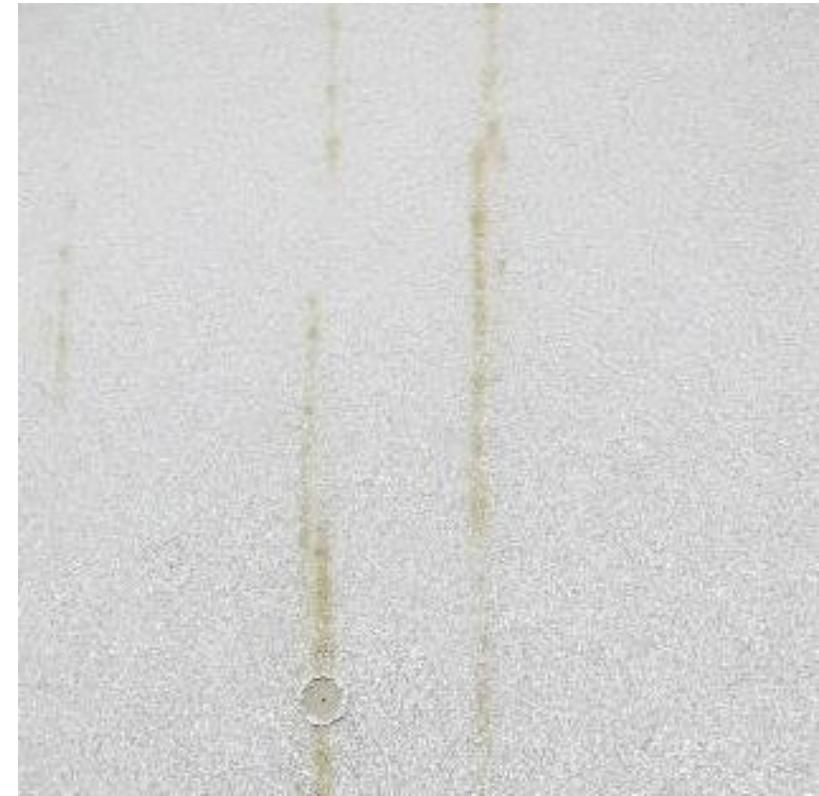
Photos: Tommy Bunch-Nielsen, BUNCH Building Physics, ApS

# Discolouring of ventilated ETICS facades

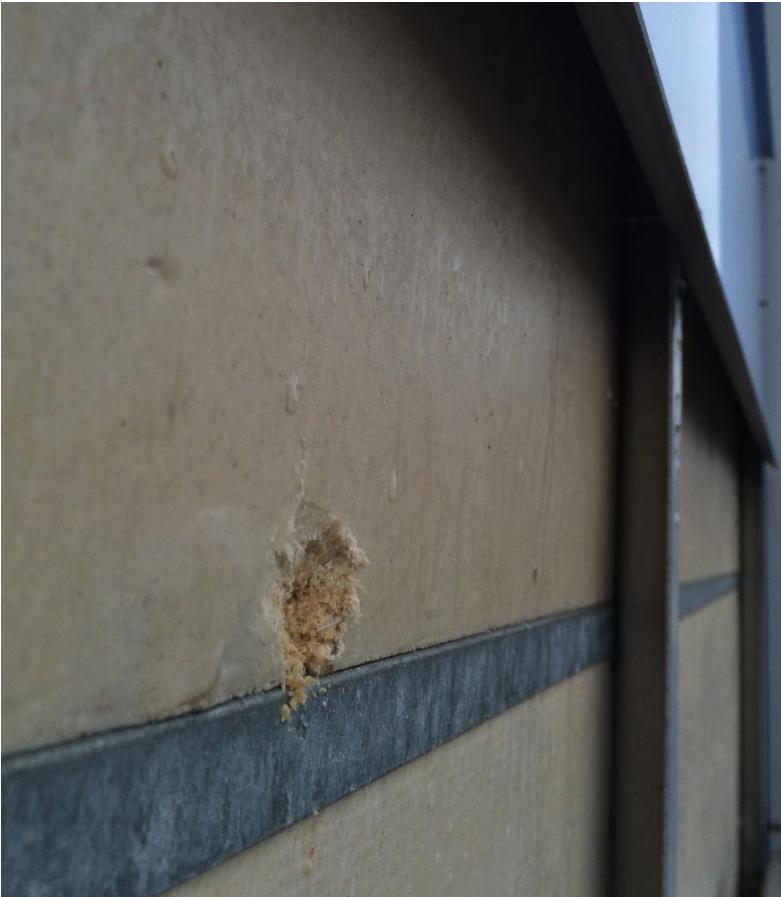
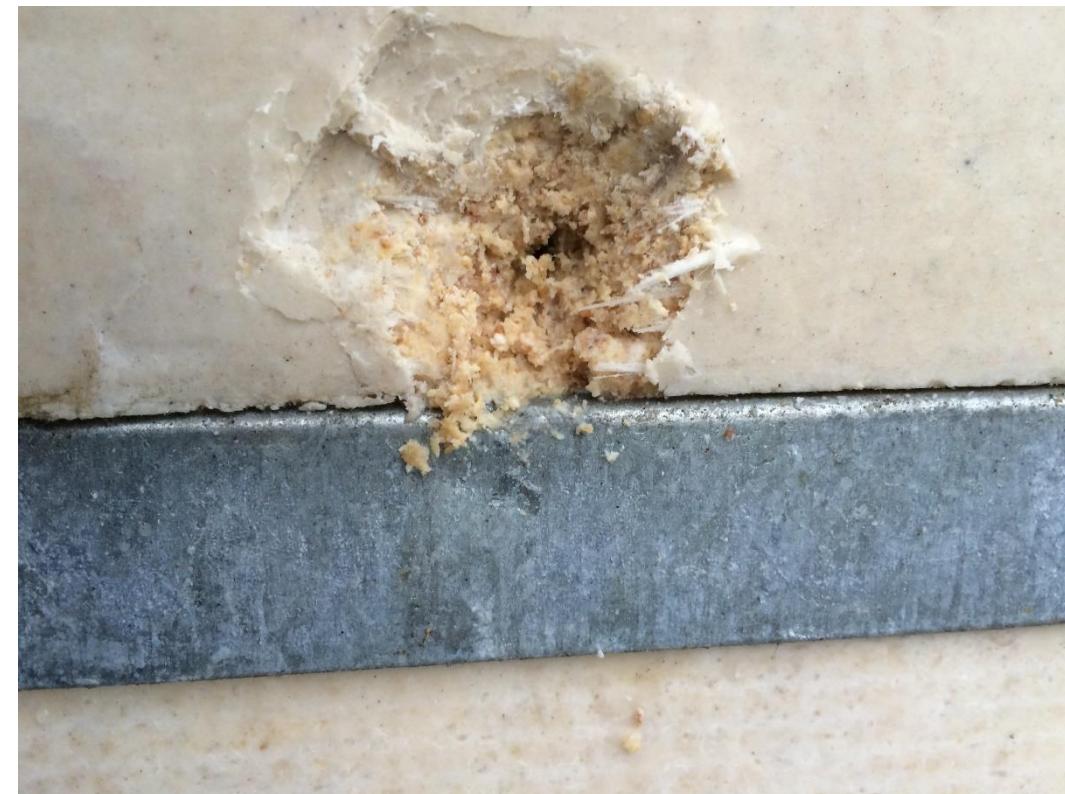
Photos: Tommy Bunch-Nielsen, BUNCH Building Physics, ApS

# Practice of Use: After long exposure the MgO-boards begin to decompose

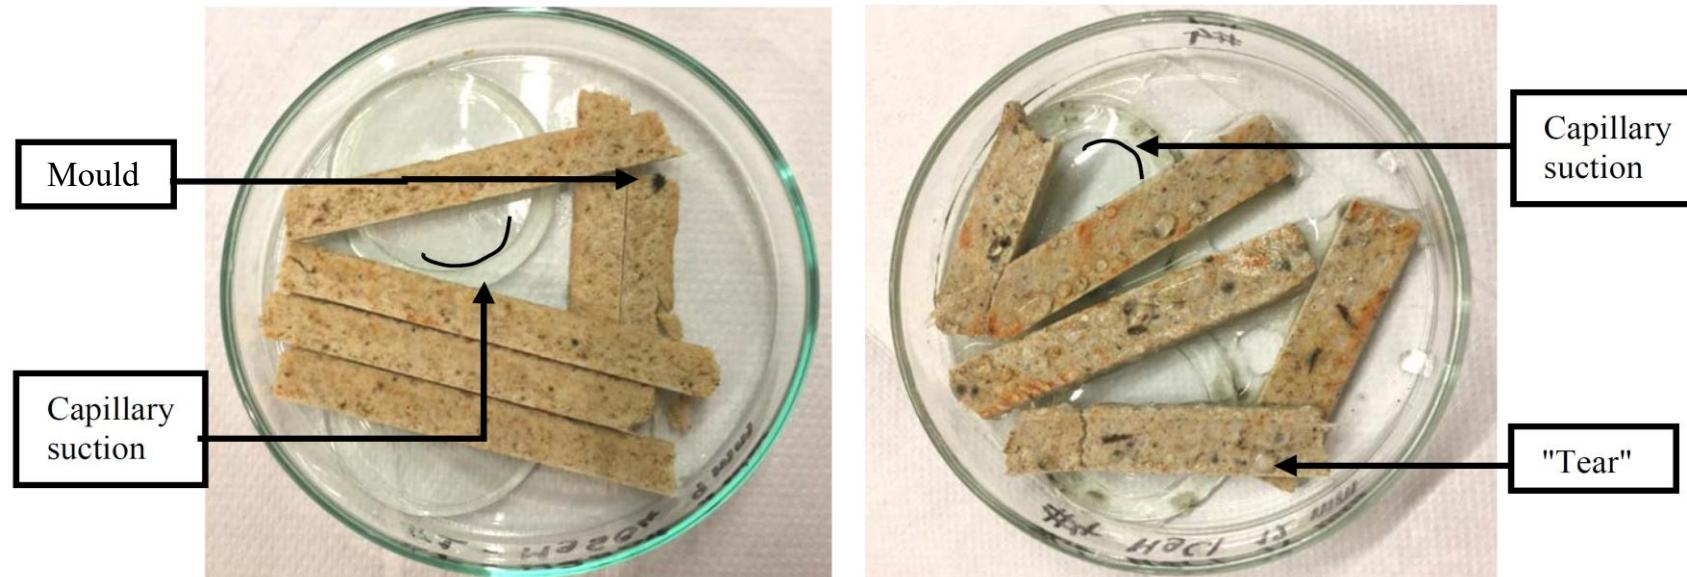
Left :  $\text{MgSO}_4$  after nine weeks

Right :  $\text{MgCl}_2$  after seven weeks

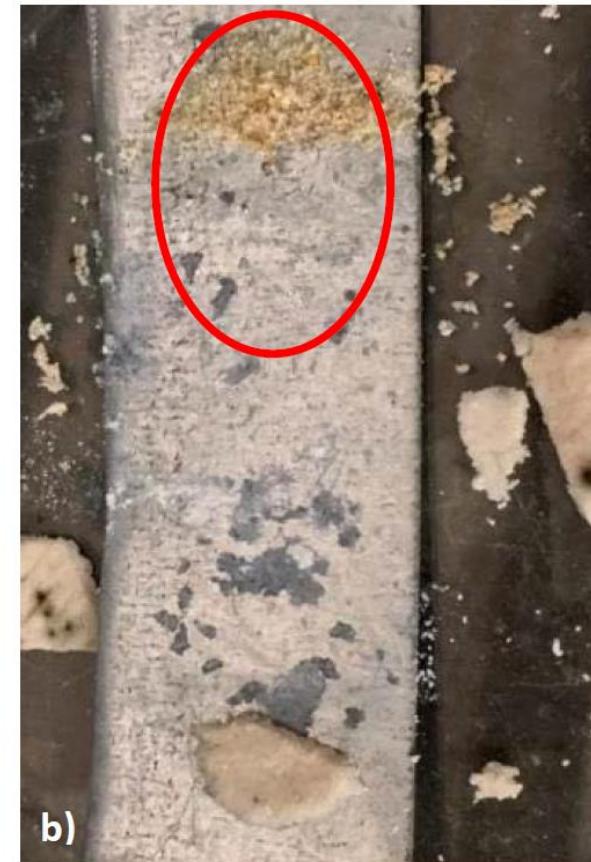
## - Corrosion test on zinc sheets

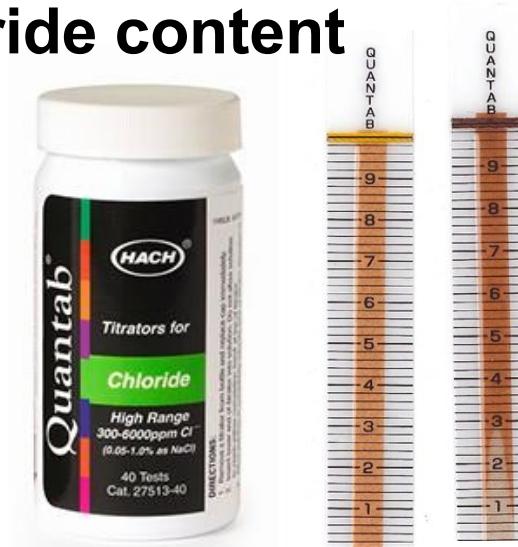
### Free chloride content

- Qualitative method
- Often used on concrete
- Forms  $\text{AgCl}_2$  (purple by exposure to light)

- Quantitative method
- Interval: 30-6000 mg/L
- Applicable on construction site

- Quantitative method
- Interval: 1-35.000 mg/L
- Interference from other, non-desired ions
